Global Safety Team (GST) Newsletter

World Chlorine Council

January 2007

Necessity of HAZOP study after any process modification

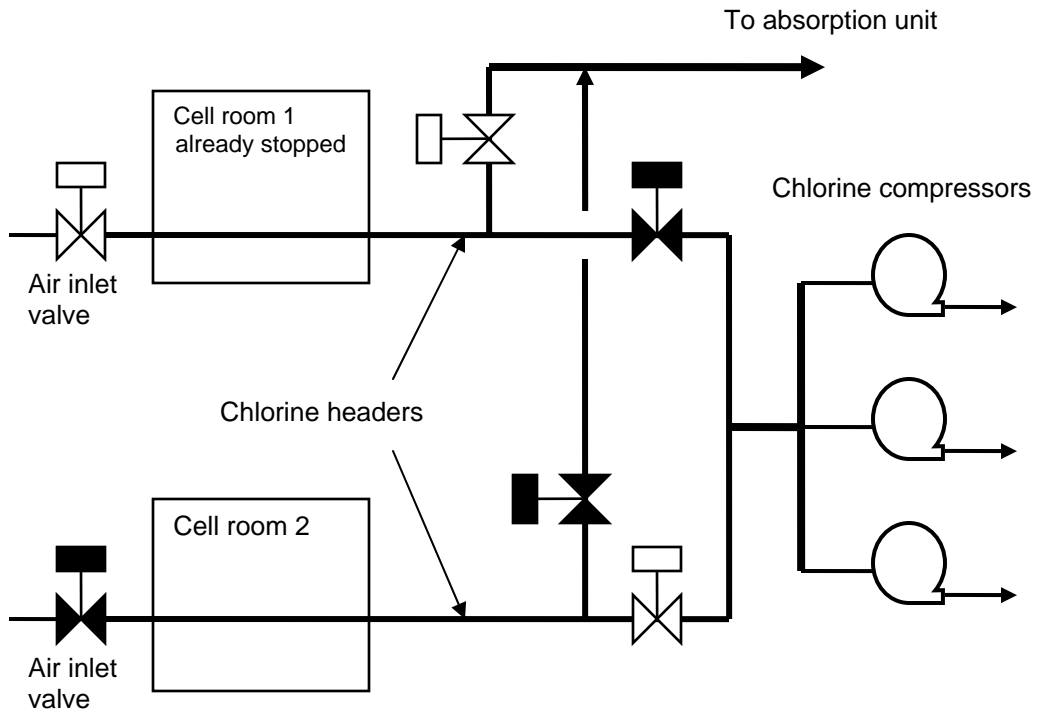
At that moment a slightly positive relative pressure developed inside the chlorine headers, due to the sudden connection of the shut-down cell room to the absorption unit, already loaded with the first cell room flushed with a too high air flow.

Chlorine escaped via the air ingress valves and a worker who was nearby at that moment inhaled some of the escaping gas.

Situation before the shut down
(the valves in black are closed)

When the cell room 2 shut down, the “white” valve closed and the 2 “black” valves opened

- increase the time delay between cell room shut down and opening of the air ingress valves,
- adjust (reduce) the ingress air flows to the value needed,
- add a logic condition in the system, checking that the pressure in the chlorine header is below zero to allow opening the air ingress valves,
